■ **Repair & Strengthening**

Repair of the Trent Street Bridge, Spokane, Washington, USA

State-of-The-Art Inspection and Grouting Remediation of Post-tensioned Tendons

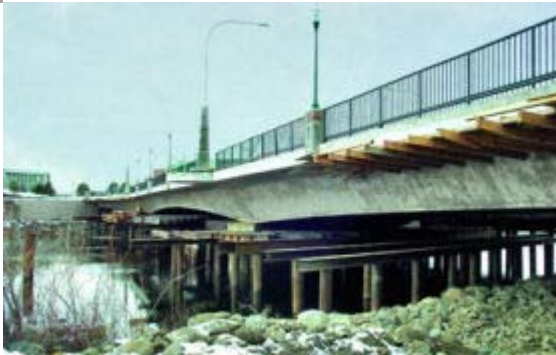
During a routine walk-through inspection an accumulation of grout was found near the low point of Web B tendons in Span 1 inside the bridge. It was decided to carry out an investigation to assess the condition of the grout inside the ducts to look for voids and subsequently fill the voids with grout.

DSI performed an NDT inspection using Ground Penetrating Radar to detect post-tensioning ducts and steel reinforcement as well as Impact Echo Scanner to detect voids in the grouted ducts. Videoscope inspections were carried out to assess the condition of the post-tensioning strands. Volumes of voids inside the ducts were measured with State-of-The-Art equipment capable of compensating for air leaks. The grouting remediation of the post-tensioned tendons in Web B was performed using vacuum grouting. DSI successfully completed the project with the preparation of a detailed report within 6 weeks.
