## ■ Marine Structures

## Rio Dam Anchored by POLYSTRAND™ HC Tiedowns

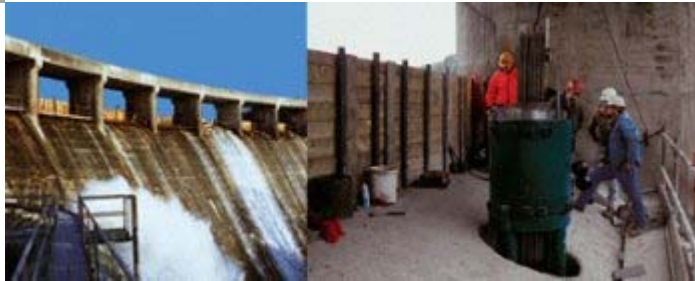
The 22 tiedowns were installed to stabilize the slightly arched spillway, 264 feet long by 101 feet high. The 55 strand tendons ranged from 134 to 161 feet. Lang's corrosion protection system covers the entire length of each tendon with a large diameter, heavy wall corrugated sheath. Each sheath had an 10 inch I.D. to fit over the massive strand bundle and within the 14.5 inch drill hole. Because of the large tendon diameter, the corrugated pipe was procured in straight lengths of 40 feet. Using an innovative electric thermowelding process, the corrugated sheath protection was assembled at the job. Each sheath was then lowered into its drill hole and grouted in place.

Preassembled POLYSTRAND anchors, with restressable anchorheads and lifting hardware already attached, arrived on site in palletized coils. Even with difficult access to the dam's crest, installation of the massive tendons was manageable through use of Lang's compact, hydraulic uncoiler. Lang's high capacity stressing system facilitated efficient and accurate anchor testing. Use of the outer full length corrosion protection encapsulation and the extruded POLYSTRAND sheath in the unbonded length, insure an extended life for Rio Dam.
